KINETICS NOISE CONTROL TEST REPORT #AT001087

Re: Dunsany Flats, Omaha NE
Post Construction Acoustical Testing

1.0 INTRODUCTION

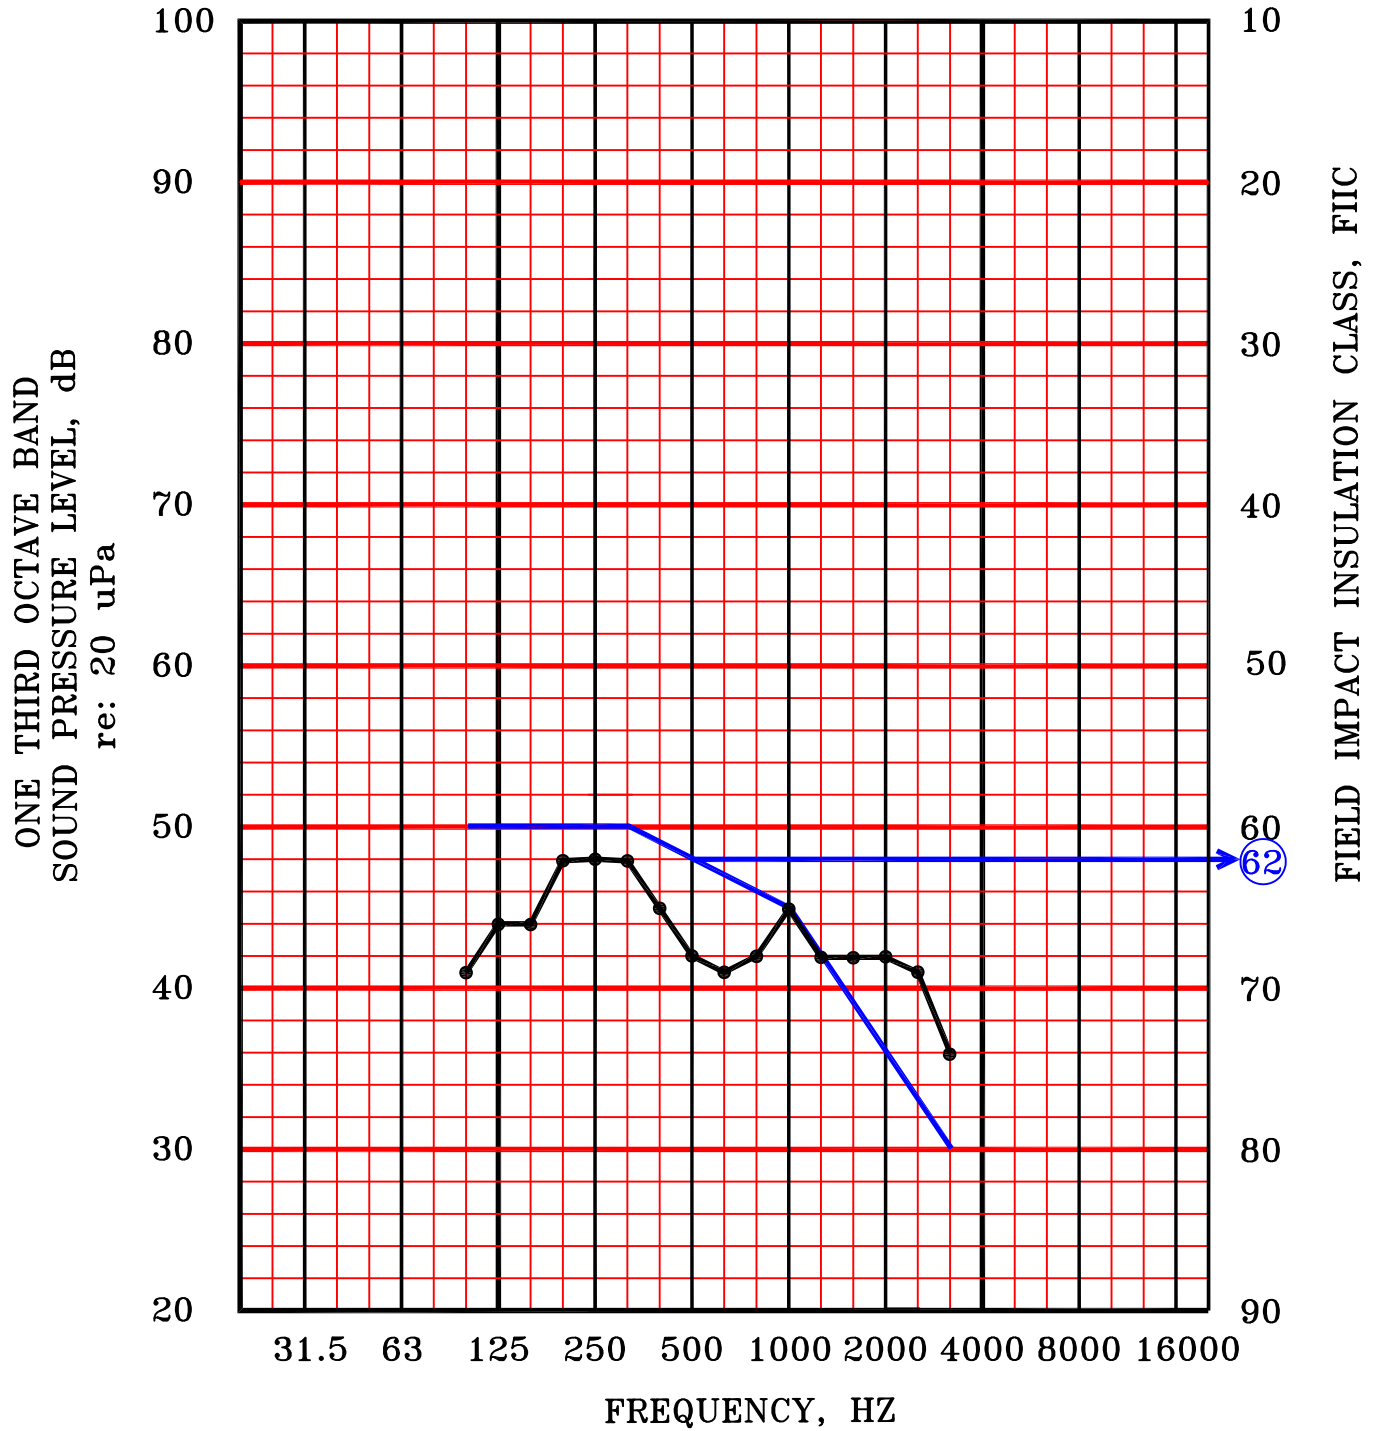
Dunsany Flats
 FIGURE 1A (4/07/2011 TESTING)
 FIIC-62

FIIC testing – Conducted in conformance with *ASTM E1007* and FIIC ratings obtained by *ASTM E989*. Tapping machine placed in second floor unit living room area with sound pressure levels obtained directly below in first floor unit living area. All measurements were averaged to steady-state conditions over approximately 60 second time intervals with negligible transient sounds during recording times with meter set to fast. The four testing positions per ASTM standard are shown below:

(SPLs obtained with Ivie IE45)

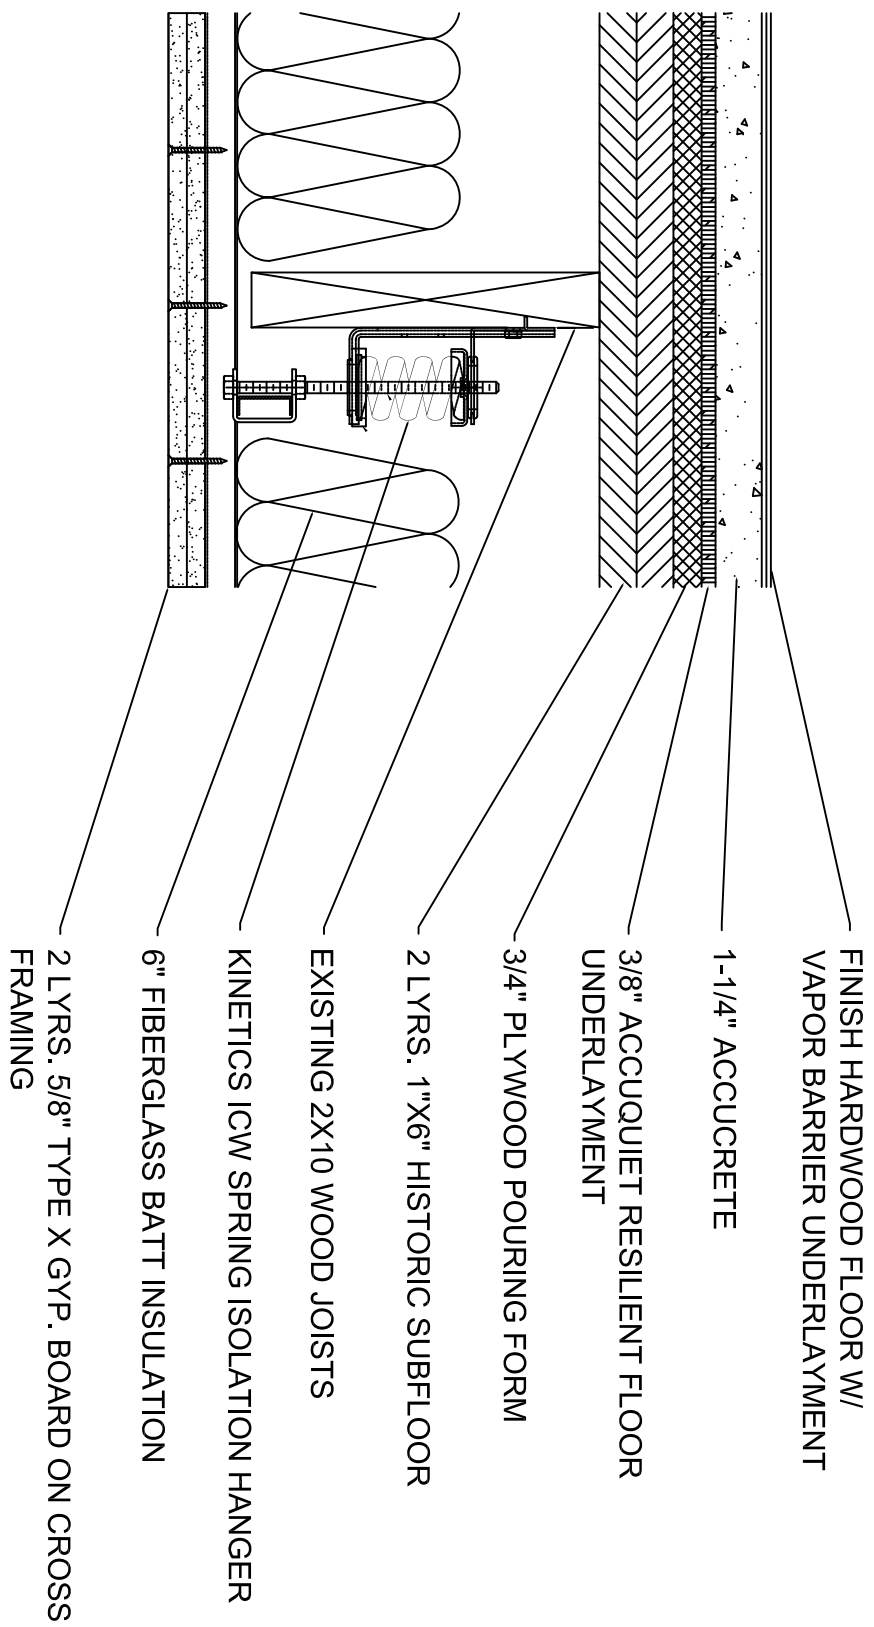
DETAIL 2

- New hardwood flooring over vapor barrier mat
- 1-1/4" AccuCrete gypsum-based concrete slab
- 3/8" AccuQuiet resilient floor underlayment
- 3/4" plywood pouring form
- 2 layers existing 1x6 wood subfloor
- Existing 2x10 joists with 6" batt insulation in cavity
- Kinetics ICW spring hangers
- 2 layers 5/8" GWB on cross framing

Both the floor and the ceiling isolation systems were installed with perimeter isolation considerations. For the floor, vertical strips of AccuQuiet were placed at the perimeter of

the floor at the floor-wall intersecions. The AccuCrete was poured to cover the complete floor with the exception of the portion of the Kitchen where floor cabinets existed, per the Owner's direction. However, isolation strips were placed at the floor-cabinet intersection to minimize the sound flanking path this was anticipated to cause.

The ceiling system was suspended so that the ceiling drywall edges were approximately 1/4" away from the walls. The gaps were then filled with foam backer rod and continuous beads of acoustical sealant. All ductwork and lighting is suspended from the noise control ceiling grid, with penetrations through the drywall sealed airtight.

FLOOR-CEILING ASSEMBLY, AFTER
